Manhole Inspection Summary

Manhole # S41AA_006MH

Inspection ☐ Is Incomplete Rating: **3) Fair**

Location Address: **rear 723 n central ave**

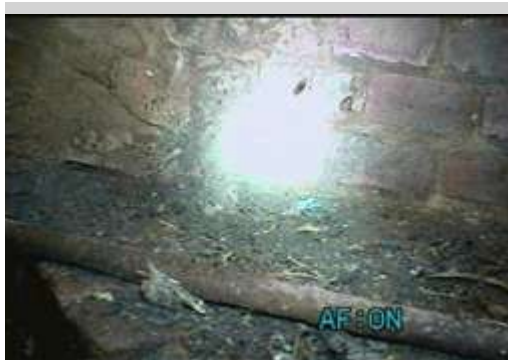
Defect 4

Condition: ☐ Sound ☐ Cracked ☐ Root Intrusion ☐ Deteriorated ☐ Leaks ☒ **Debris**

bench debris

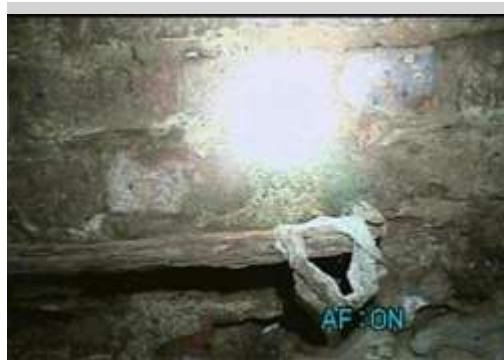
Defect 3

☒ **Evidence Of Surcharge** Depth: **2.1** (ft.) ☐ Active Surcharge Present

evidence of surcharge

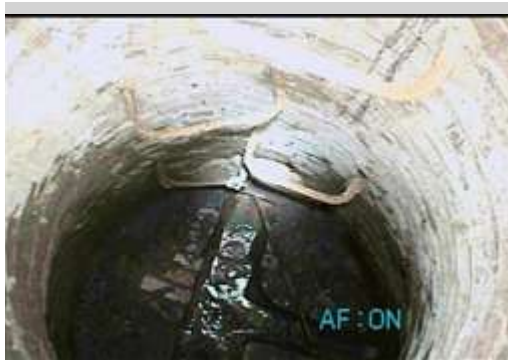
Defect 2

Count: **4** Missing: **0** ☒ **Corroded**

steps

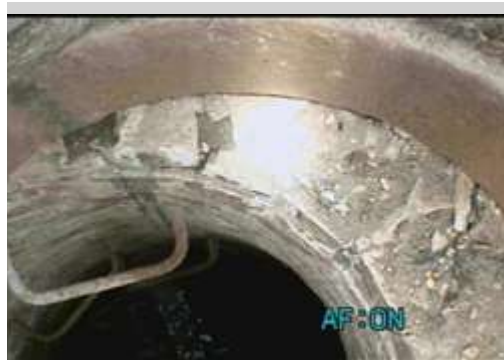
Defect 1

Offset: **5.5** (in.)

offset

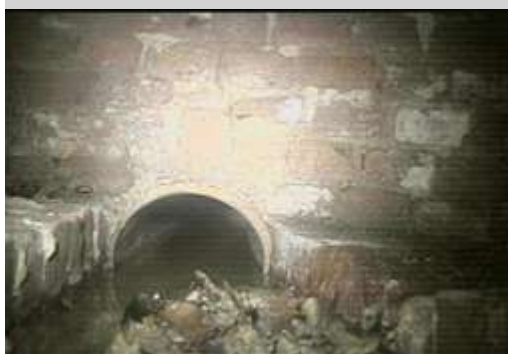
Defect 1

Condition: ☐ Sound ☐ Cracked ☐ Root Intrusion ☐ Deteriorated ☐ Leaks ☒ **Debris**

channel debris

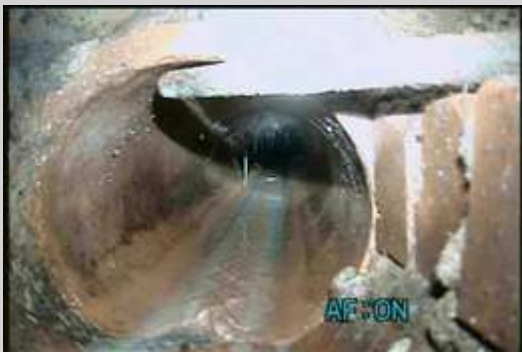
12 O'Clock Outflow

Deposits: ☐ None ☐ Mud ☐ Sludge ☒ **Debris** ☐ Grease

Silt Depth: 1 (in.) Deposits Extent: **Light**
